# HELIFIX

Retrofit Helical Wall Ties and  
Reinforcements for Seismic Upgrades

# Seismic Upgrades

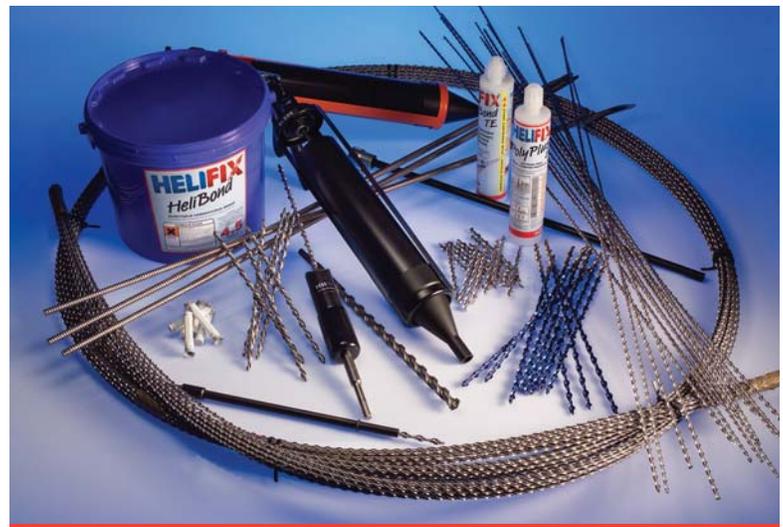
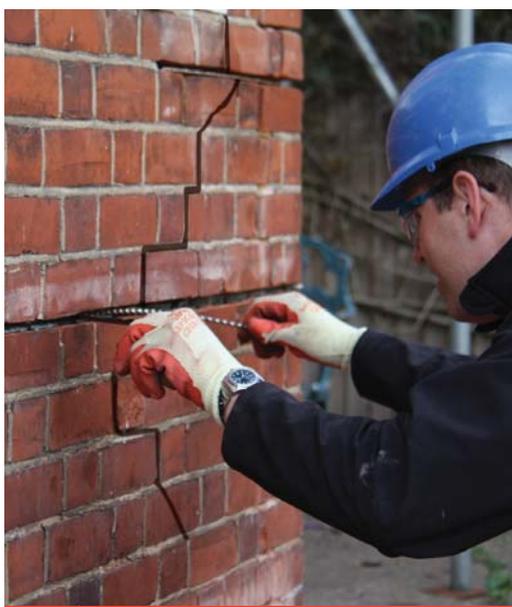
Tying masonry together to distribute loads and improve ductility

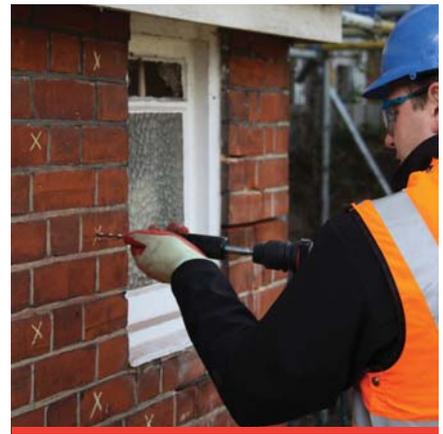
Tying wall junctions

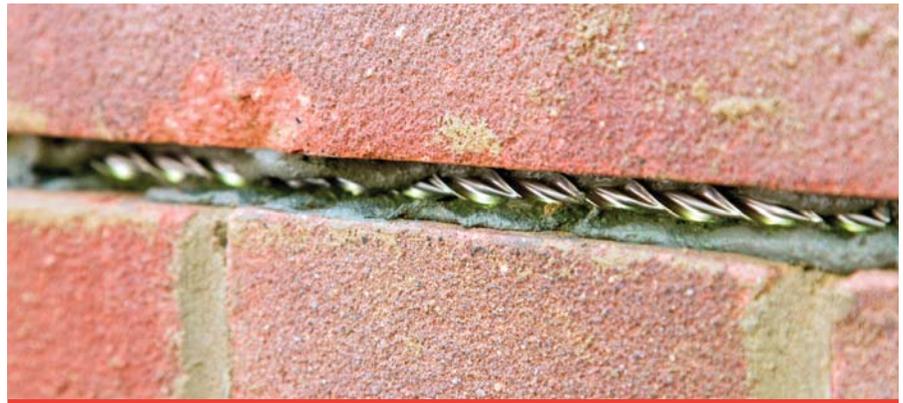
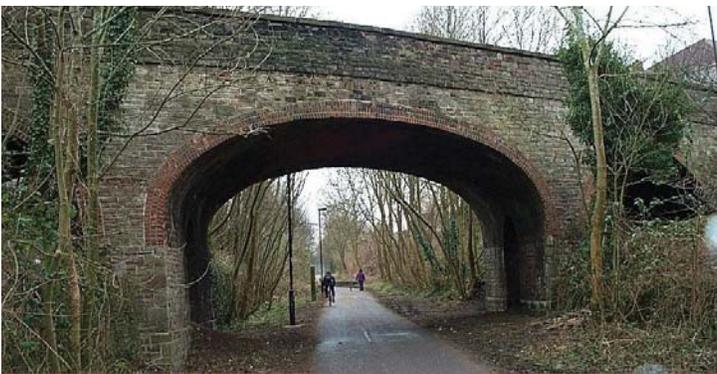
When used in combination with HeliBar reinforcement, Helifix ties can be installed to achieve positive results across a wide variety of applications from replacing wall ties and restoring structural integrity to individual masonry panels, to adding strength and ductility to complex masonry structures like arch bridges and tunnels.

Securing brick arches and lintels
